acoustic microscopy

Plastic components

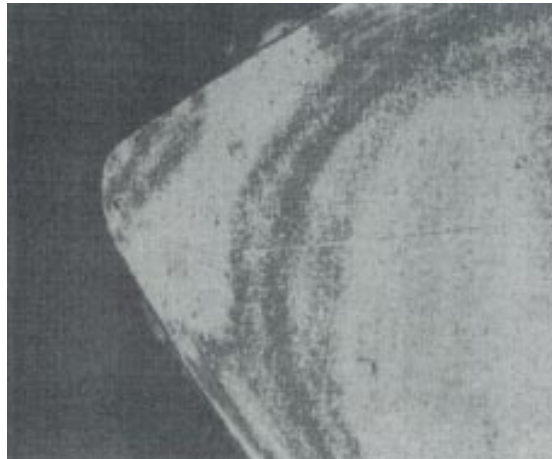
Fig. a: Apart from a void (air inclusion), the tip of a gear wheel also exhibits material inhomogeneities (consolidations),

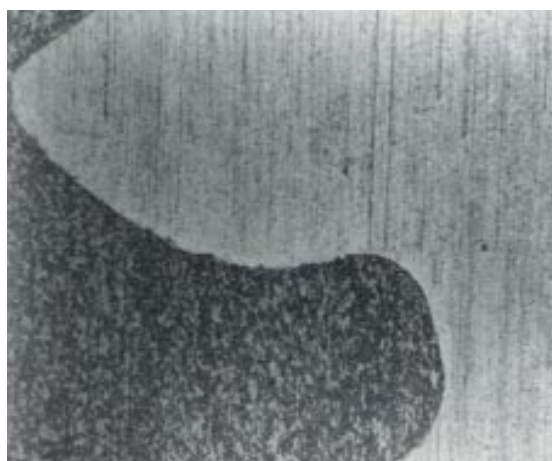
Fig. b: On this part of the gear wheel scratches can be seen which were probably caused during aftertreatment of the surface.
