# Extending Acoustic Microscopy for Comprehensive Failure Analysis Applications

Sebastian Brand, Matthias Petzold Fraunhofer  
Institute for Mechanics of Materials Halle,  
Germany

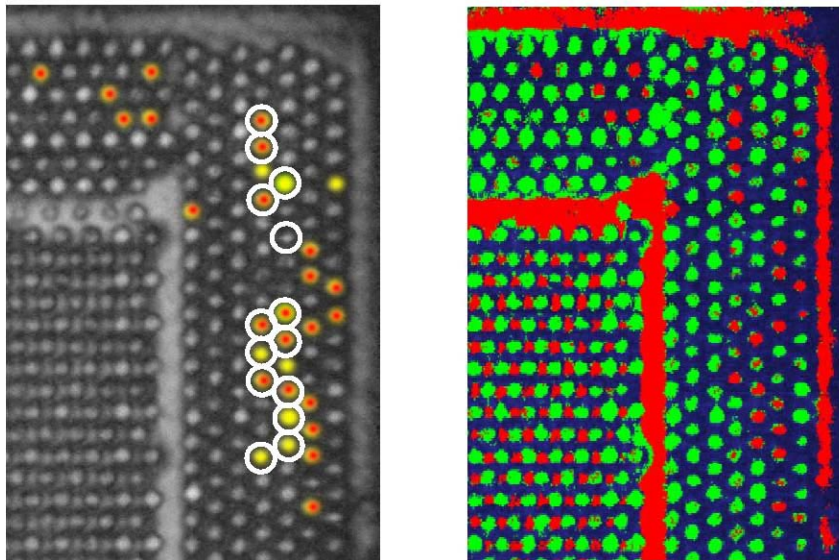
Figure 4: Classification results and evaluation of void detection. Right: green indicated are detected flip-chip contacts. Red connectors were classified as voids based on the wavelet coefficients and pulse separation characteristics at the interface silicon/ solder bump. Left: BAI-parametric image with indication of detected voids. Yellow marks correspond to voids detected using acoustic microscopy data. Red marks show where voids have been confirmed by X-ray microscopy. White circles show where defect connections were verified by cross-sectioning and SEM imaging. SEM investigations were only performed on column 3 and 4 (counted from the right-hand-side of the device).

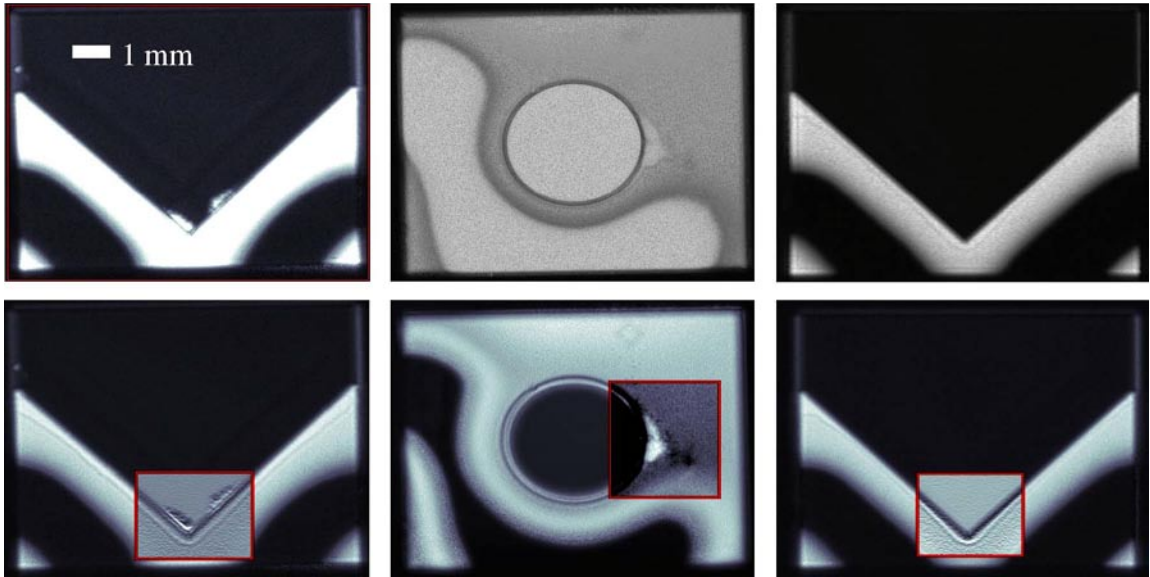
Figure 5: Image analysis applied to acoustic micrographs. Top: pure intensity images obtained by an acoustic microscope. Bottom: processed acoustic images. Image filters for blind-deconvolution and a Gaussian filter were applied to emphasize the defect and for increasing the resolution. A Sobel filter was applied in the lower left-and right images for detecting the contour and orientation of the defects.
