Extending Acoustic Microscopy for Comprehensive Failure Analysis Applications

Sebastian Brand¹, Peter Czurratis², Peter Hoffrogge², Matthias Petzold¹

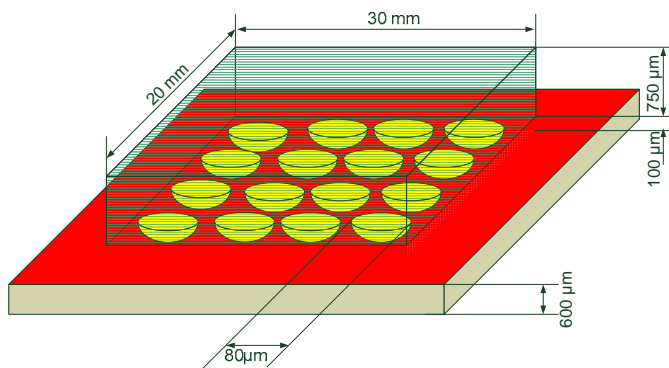
Figure 2: Sample description for signal analysis and defect evaluation. The sample was a CPU device manufactured in flip-chip technology on top of an organic substrate. The dies thickness was $750\ \mu\text{m}$, with flip-chip contacts of height $100\ \mu\text{m}$ and diameter $80\ \mu\text{m}$. The lateral dimension of the die was $20\ \text{mm}$ by $30\ \text{mm}$. Acoustic inspection was performed through the die after the cap of the CPU was removed.

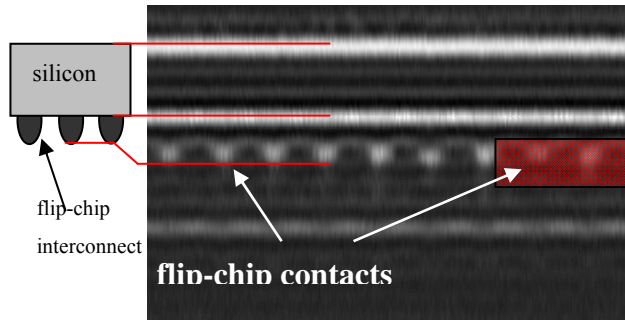
Figure 3: Internal sample structure and echo signal occurrence. The schematic on the left illustrates the 750 μm silicon layer with the flip-chip contacts underneath. On the right, an acoustic cross-section image through the CPU-device is shown. Boundaries and corresponding echoes are indicated by red lines. The red rectangle shows the time range for estimating BAI values.

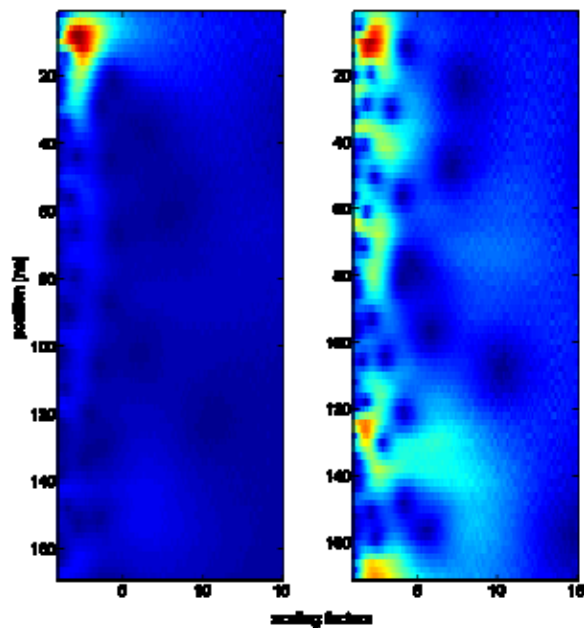
Figure 8: Wavelet coefficients estimated at the silicon/solder interfaces of an intact (left) and at a defect interconnect (right).

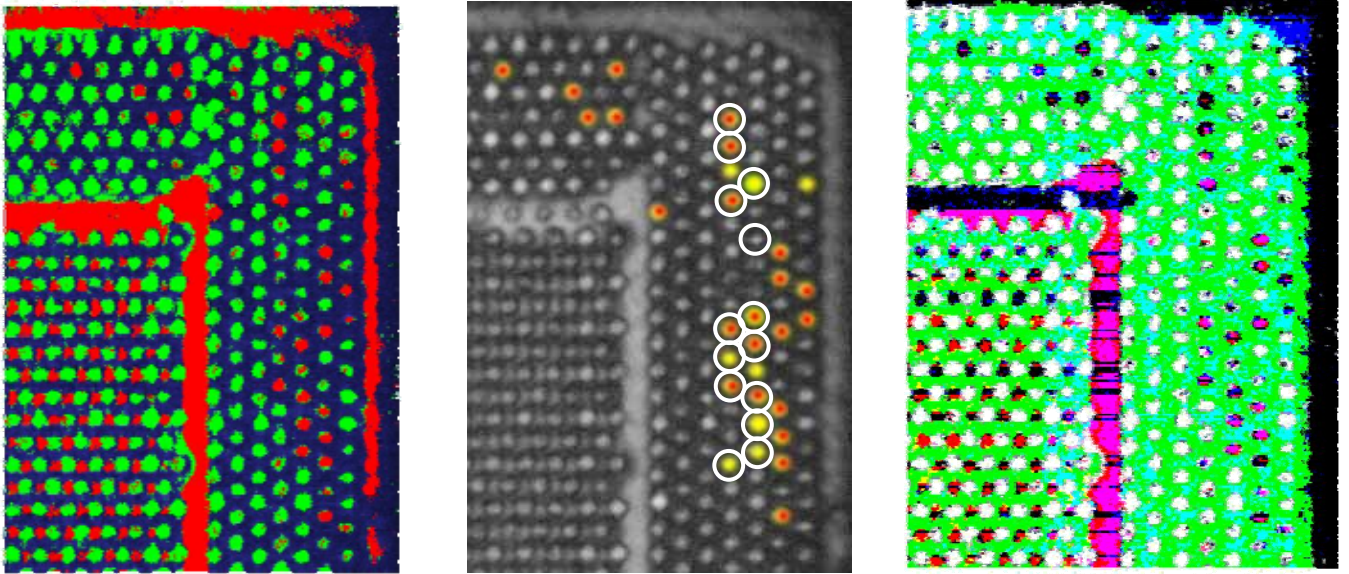
Figure 9: Classification results and evaluation of void detection. LEFT: green indicated are extracted flip-chip contacts. Red interconnects were classified as voids based on the wavelet coefficients and pulse separation characteristics at the interface silicon/ solder. CENTER: BAI-parametric image with indication of detected voids. Yellow marks correspond to voids detected using acoustic microscopy data. Red marks indicate where voids were confirmed by X-ray microscopy. White circles indicate where defect contacts were verified by cross-sectioning and SEM imaging. SEM investigations were only performed on column 3 and 4 (counted from the right-hand-side of the device). RIGHT: superimposed parameter maps. Red indication corresponds to pulse separation in the “void-range”. Blue marks indicate the wavelet coefficients and green stains everything that is not detected as an interconnect.

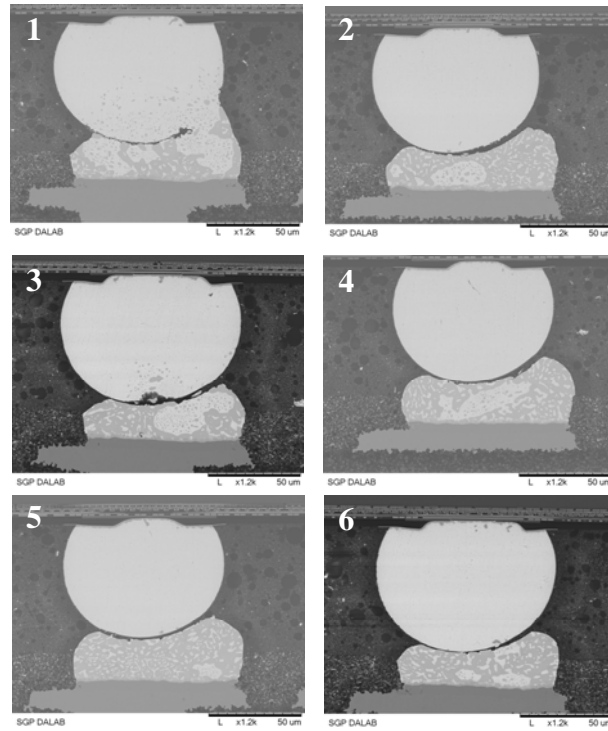
Figure 10: Scanning electron micrographs of defective flip-chip interconnects in the investigated CPU-device. The numbering corresponds to the numbering in Fig.9-center which shows the lateral positions of the contacts.

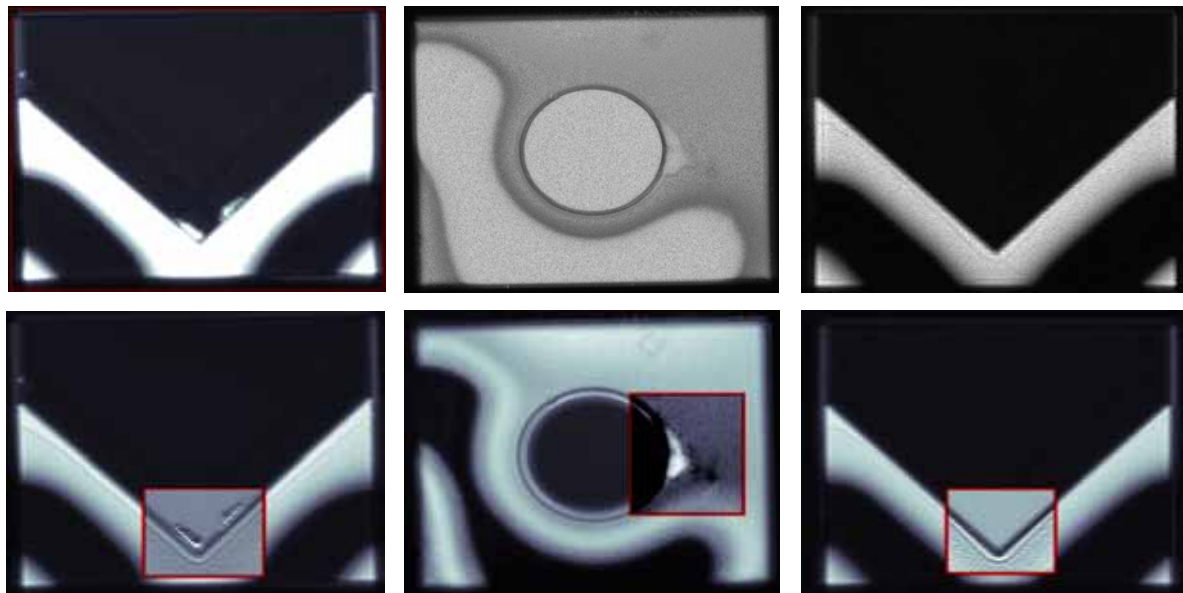
Figure 11: Image analysis applied to acoustic micrographs. Top: pure intensity images obtained by an acoustic microscope. Bottom: processed acoustic images. Image filters for blind-deconvolution and a Gaussian filter were applied to emphasize the defect and for increasing the resolution. A Sobel filter was applied in the lower left- and right images for detecting the contour and orientation of the defects.

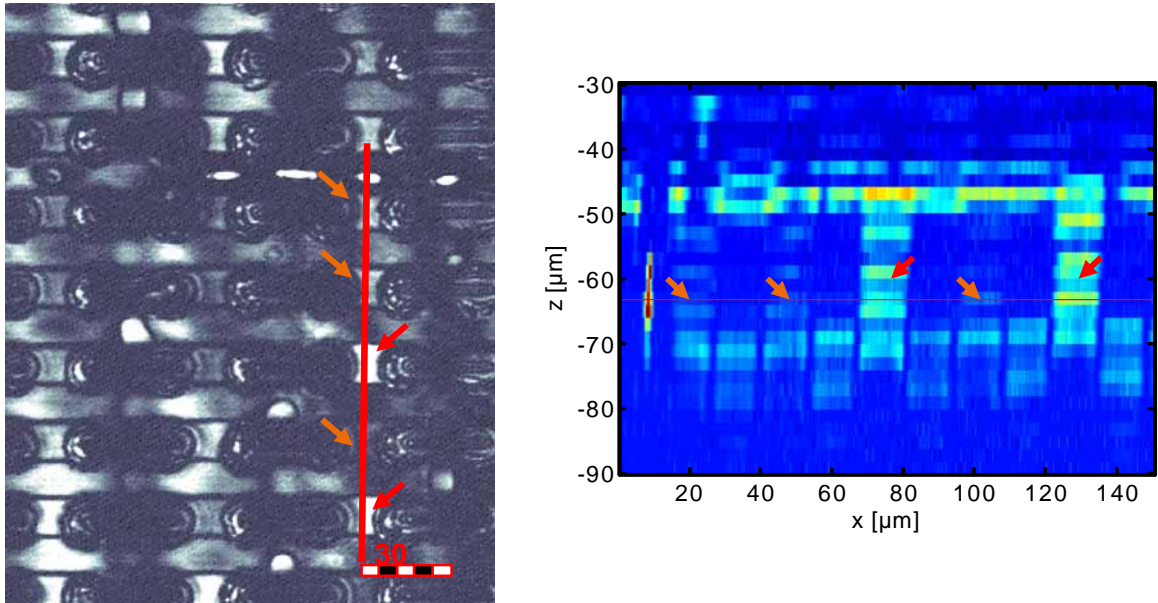
Figure 12: Acoustic GHz-Microscopy data acquisition at decreasing distances between acoustic lens and sample surface. Left: Acoustic micrograph recorded with sufficient defocus for imaging the electrical routings between the micro-bumps. This layer is buried behind 5 μm of BCB. Right: Acoustic cross-section along the red marked line in the acoustic micrograph (right). At approx. -45 μm the sample surface is in focus. The image displayed on the right was recorded at approx. -60 μm which corresponds to a defocus of 15 μm .

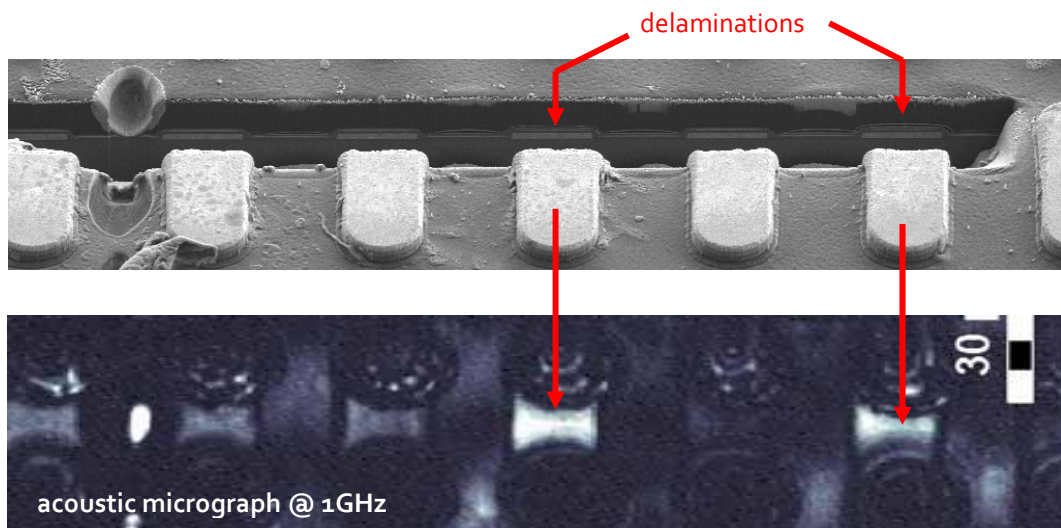
Figure 13: Acoustic GHz-Microscopy for localizing defects in the electrical routings. TOP: SEM image with a FIB created trench for micro cross-sectioning. Bottom acoustic micrograph recorded at 1 GHz with the acoustic focus placed inside the specimen. Delaminations (indicated by the arrows) appear bright in the acoustic micrograph.

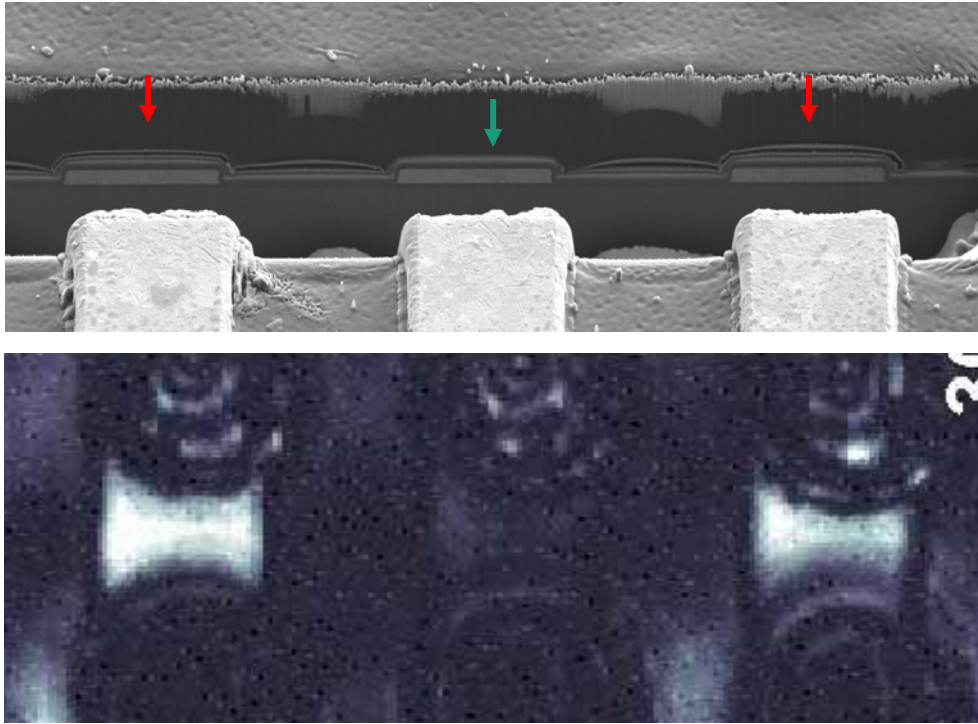
Figure 14: Acoustic GHz-microscopy at 1 GHz with enlarged SEM image for displaying the detail of the delamination. TOP: SEM image of the FIB processed trench. Bottom corresponding acoustic micrograph. Delaminations are clearly visible in the SEM image that confirms the findings of the acoustic microscopy.
