acoustic microscopy

Cracks in hardmetals

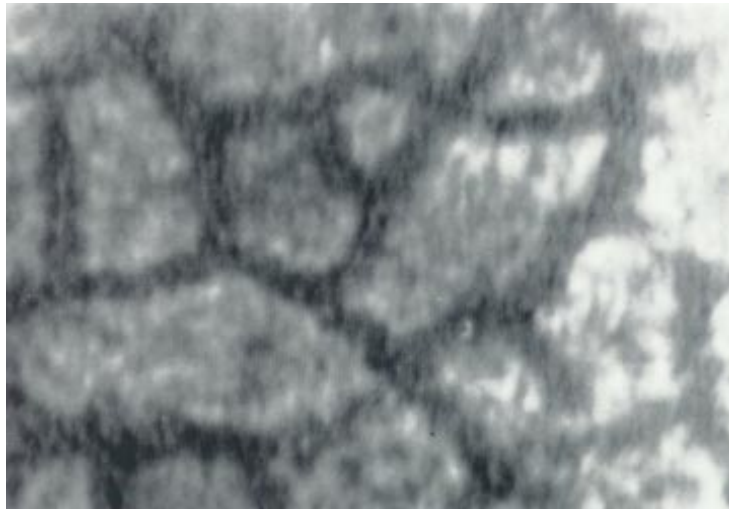
Fig. a: One of the high temperature failure mechanisms in hardmetal, or cermets, is creep cracking induced by a combination of high temperature and subcritical stress. This specimen of WC-6 % Co was heated to 850°C, near to the ductile-brittle transition temperature. A brittle pre-crack had been induced by indenting at room temperature. When a similar specimen was heated to the same temperature, and subjected only to an instantaneous load, no crack extension was observed. This specimen was held at load for 12 minutes, and extensive crack growth occurred. In particular, evidence can be seen of secondary microcracking, and void nucleation and growth.
