Extending Acoustic Microscopy for Comprehensive Failure Analysis Applications

Sebastian Brand, Matthias Petzold Fraunhofer
Institute for Mechanics of Materials Halle,
Germany

Peter Czurratis, Peter Hoffrogge PVA
TePla Analytical Systems GmbH
Aalen, Germany

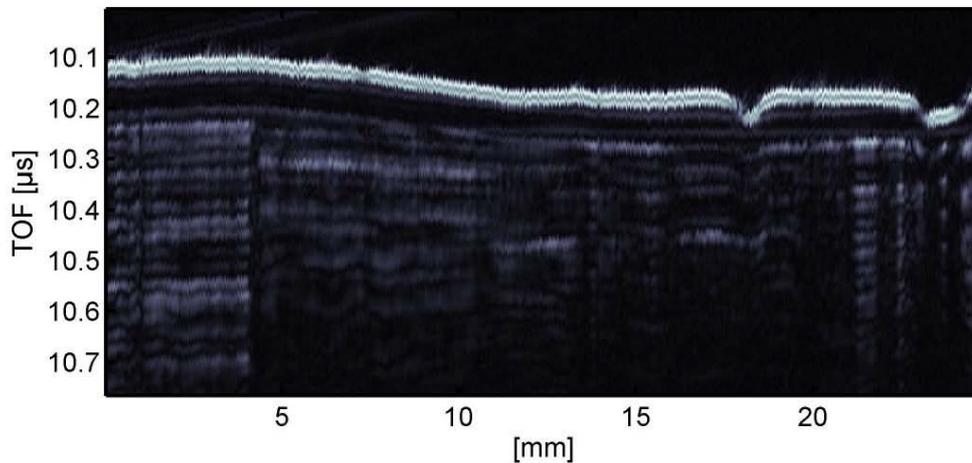
Figure 1: Top: Acoustic micrograph of a solar panel showing the solder tape in the vertical center. The gray values correspond to the magnitude of the surface echo. Bottom: Cross section of the solder tape along the red-marked line in the Top image. Echoes occurring below the surface are characterized by the structure of the solder tape and the solder and thus contain information on the solder adhesion.

The connectivity of a solder tape on top of a solar panel was assessed by computing the position of the first cepstral maximum from time domain signals acquired using acoustic microscopy. Figure 1 shows a regular acoustic micrograph of the solar panel with the solder tape in the vertical center. The time domain signals are plotted as a cross section in Figure 1 (bottom). This cross section corresponds to the red-marked line in Figure 1 (top).

It can be seen that the echo distribution is not homogeneous over the cross section. On the left side the solder tape is detached (delaminated) from the bus bar of the solar panel which causes multiple reflections of the acoustic signal in the tape. By applying a cepstral analysis the echo separation and periodicity was extracted. The parameter matrix containing the position of the first cepstral maximum is plotted in Figure 2. This parameter map corresponds well to the location of the defects enabling a simplified assessment of the solder quality of the contact tape.

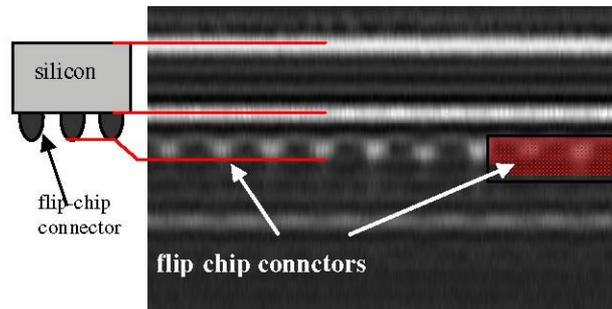
Figure 3: Sample description. The schematic on the left illustrates the 750 μm thick silicon die with flip-chip solder contacts (80 μm lateral diameter) underneath. On the right a cross-sectional B-mode image through the CPU-device is shown. Boundaries and corresponding echoes are indicated by red lines. The red rectangle shows the time range for estimating BAI values.

Figure 3 shows a cross section through the CPU device investigated for the development of an automated inspection/classification method for flip-chip contacts. The corresponding interfaces are indicated by the schematic to the left of the cross section. The echo pulses in the red-marked time-range were applied to further inspection using wavelet-, pulse separation and BAI analysis. It was found that in case of a void wavelet coefficients were distributed almost equally over the scaling factors and the wavelet positions, while intact connectors only showed a narrow distribution. The separation of echoes (entrance/exit of the flip-chip contact) obtained at intact interconnects were up to 20 ns smaller than for voids, also BAI values were observed to be significantly higher at intact connectors than at voids. All three parameters were combined in a classifier and applied to the acoustic data recorded from the CPU. The automated operating tool indicated intact contacts in the BAI image by a green mark, while voids are marked red. Figure 4 (right) contains the result of the automated classification. For verification X-ray and SEM analyses were performed on the device. In Figure 4 (left) yellow marks indicate voids detected by the acoustic method developed here. Each of the void which was confirmed by X-ray is indicated red. Two rows containing the majority of defects were cross-sectioned and imaged by SEM. Voids confirmed by SEM are indicated by a white circle. From Figure 4 (left) it can be seen that 13 voids were confirmed by SEM and that five voids have not been found by X-ray. However, two false positive and one false negative classification occurred, resulting in an overall success rate of 90.3% for the acoustic detection method.

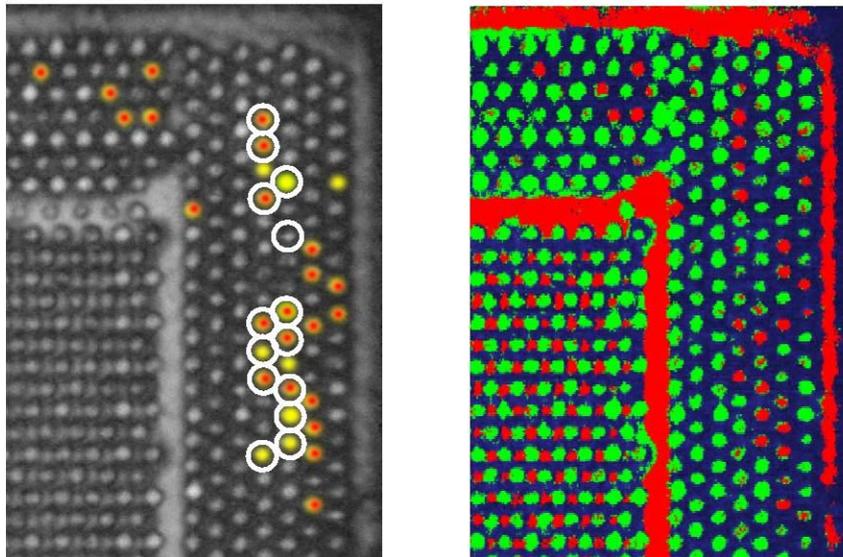
Figure 4: Classification results and evaluation of void detection. Right: green indicated are detected flip-chip contacts. Red connectors were classified as voids based on the wavelet coefficients and pulse separation characteristics at the interface silicon/ solder bump. Left: BAI-parametric image with indication of detected voids. Yellow marks correspond to voids detected using acoustic microscopy data. Red marks show where voids have been confirmed by X-ray microscopy. White circles show where defect connections were verified by cross-sectioning and SEM imaging. SEM investigations were only performed on column 3 and 4 (counted from the right-hand-side of the device).

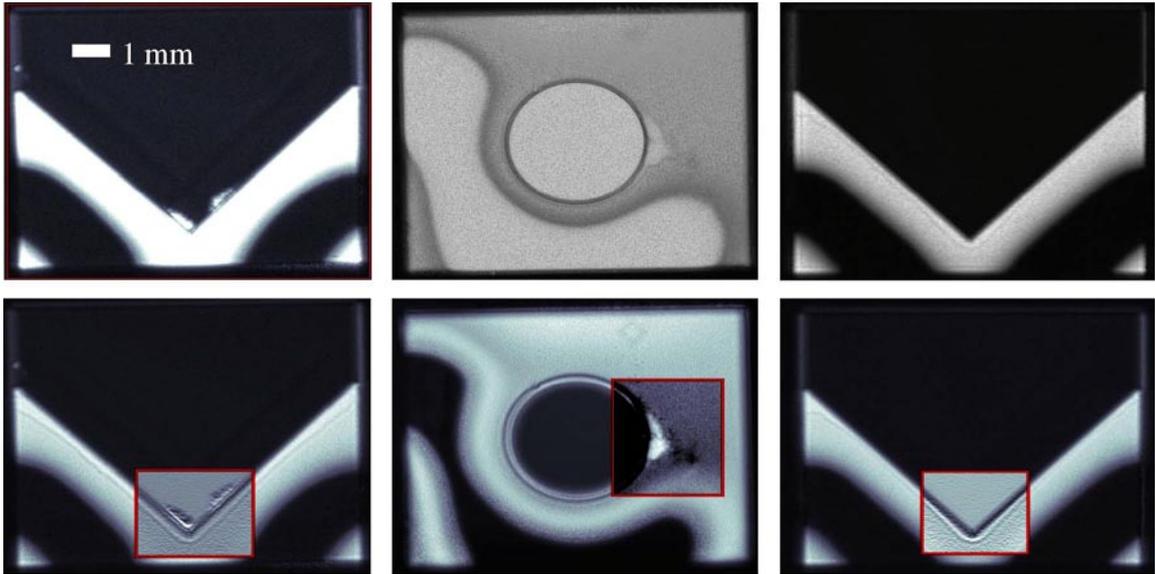
Figure 5: Image analysis applied to acoustic micrographs. Top: pure intensity images obtained by an acoustic microscope. Bottom: processed acoustic images. Image filters for blind-deconvolution and a Gaussian filter were applied to emphasize the defect and for increasing the resolution. A Sobel filter was applied in the lower left-and right images for detecting the contour and orientation of the defects.

Image processing was applied to acoustic micrographs recorded from the bonding interface of wafer bonded structures. The acoustic micrographs did not show sufficient contrast and sharpness to clearly evaluate defects located at the bonding interface. In Figure 5 the acoustic micrographs prior to the image processing are plotted in the upper row. Performed was blind-deconvolution for increasing the sharpness of the images. Additionally, a Sobel filter was applied to the region of interests (ROIs) in the left and right images in Figure 5. A Gaussian Filter was applied to the central image in Figure 5. In all three cases the visualization of defects in the bonding interface was optimized. The lateral dimensions and the shape of the defects are clearly visible.
