acoustic microscopy

Thrombus formation in a rat experimental model

This report presents briefly some of the preliminary images obtained in rats in- and ex-vivo at the Leica Scanning Acoustic Microscope Application Laboratory. Our study concerned the imaging of the thrombus in a 0,7 mm diameter femoral artery in a living anaesthetised rat and imaging of the same artery after its removal from the animal.

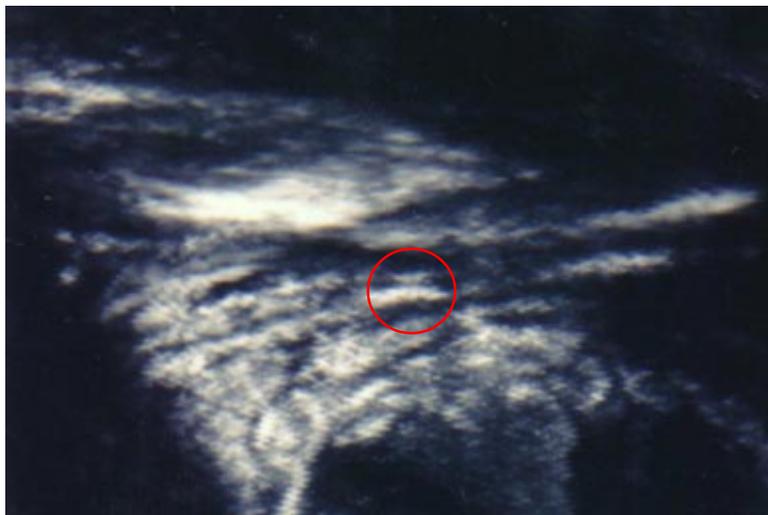
Fig. 1: The image obtained in-vivo at a frequency of 25MHz with a field view of 8x8mm. The femoral artery (marked by circle) is seen running parallel to the femoral vein. Due to the fact that the animal is alive, blood is passing continuously within the artery at a pulse rate of approximately 400 per minute during the ultrasonic scanning. Contrast changes in the artery and vein are apparent in the SAM-image due to the different acoustic properties of the vessel wall and the blood.

After surgery the rat was placed in a glass container filled with warm saline that acted as coupling liquid. The head was kept above the saline. The rat was then placed in the KSI SAM 50 and the femoral vessels were scanned at 25 MHz (Fig. 1)

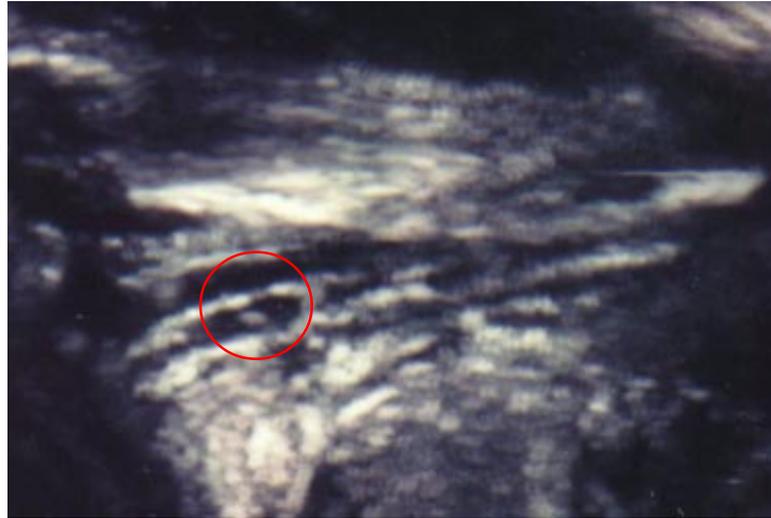
Fig. 2: The image obtained in-vivo at a frequency of 25MHz with a field view of 8x8mm. Again the femoral artery is seen running parallel to the femoral vein. The arterial wall is clearly distinguished from the lumen (centre) of the artery. The circle indicates a narrowing of the arterial lumen that may correspond to the site of injury. The thrombus could be seen in the centre of the marked area.

Following this 25 MHz scanning a thrombogenic injury was performed on the femoral artery. The artery was incised transversely over one-third of the circumference and the defect closed with special sutures that intentionally inverted a full thickness section of the arterial wall into the centre of the artery. Within a few minutes a thrombus formed at this site and the rat was again placed in the container with coupling liquid, placed in the KSI SAM 50 and scanned 25 MHz (Fig. 2)

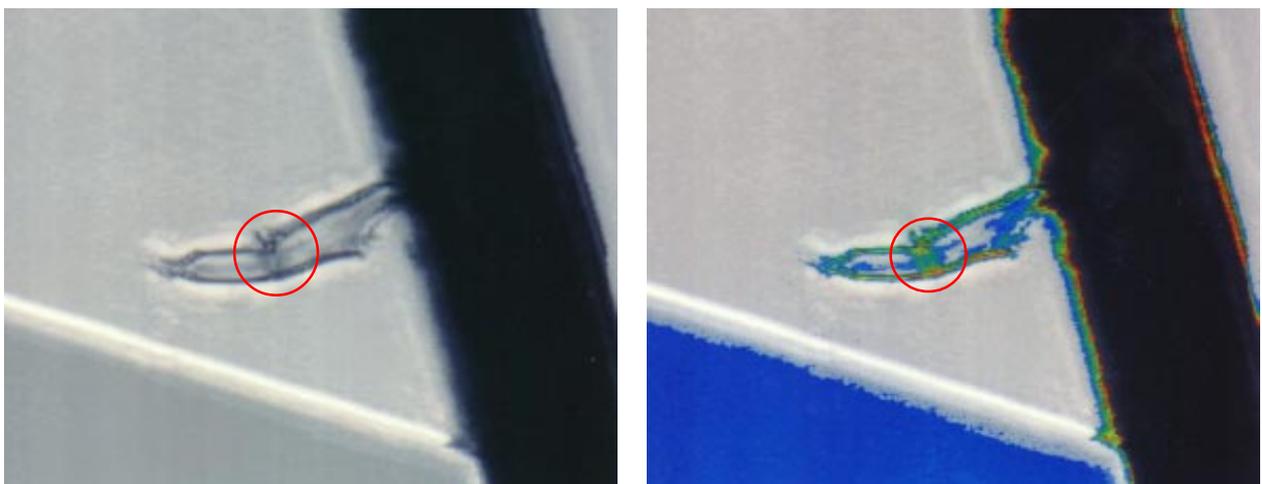
Fig. 3: The image obtained ex-vivo at a frequency of 25MHz with a field view of 8x8mm. The femoral artery is seen with the legated ends and side vessel. A dark area that may depict a thrombus is seen in the lumen below the sutures

For ex-vivo scanning of the artery with the thrombus, a section of the artery comprising the site of injury and approximately 2-3 mm of the artery on each side of this was ligated and excised. In this way any thrombus material and blood were captured inside the artery. The artery was then placed in the KSI SAM 50 and the SAM 2000 and scanned at 25 and 200 MHz, respectively (Fig. 3 and 4).
